# INSTRUCTIONS

J02037

## FAIRING BRA

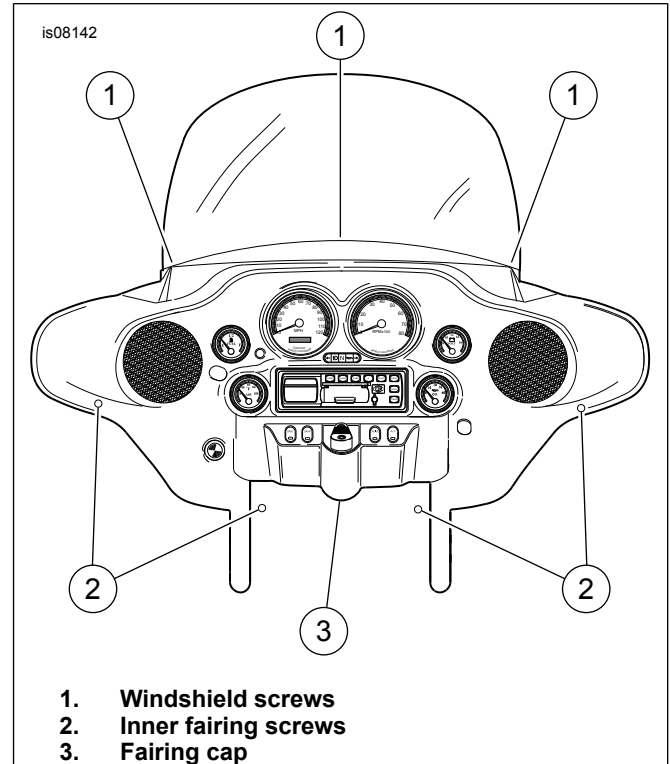
Figure 1. Windshield and Fairing Hardware

1. Align each of the sewn-in pockets on the fairing bra with each of the outer edges of the fairing at handlebar level.
2. See Figure 1. Standing in front of the vehicle, remove the three T27 Torx screws (1) with washers securing the windshield along the front of the fairing.

3. Obtain the Chrome Windshield Strip (P/N 59213-96) and screws supplied with strip. While aligning holes in the chrome strip over the bra, install the new screws with washers through the strip and bra, then tighten securely into the windshield.
4. See Figure 1. The six straps (three on each side near the bottom) will be captured between the inner and outer fairing. Remove the four screws (2) from the inner fairing. NOTE: The bottom two screws are below the fairing cap. Save screws for installation. Separate the inner and outer fairings just enough to install the straps into the fairing. Adjust the straps, then install the screws and tighten securely.
5. Remove the Phillips screw located at the bottom of the headlamp trim ring. Save screw for installation.
6. See Figure 2. Orient the elastic portion of the bra around the headlamp, however in front of, the retaining ring as shown.

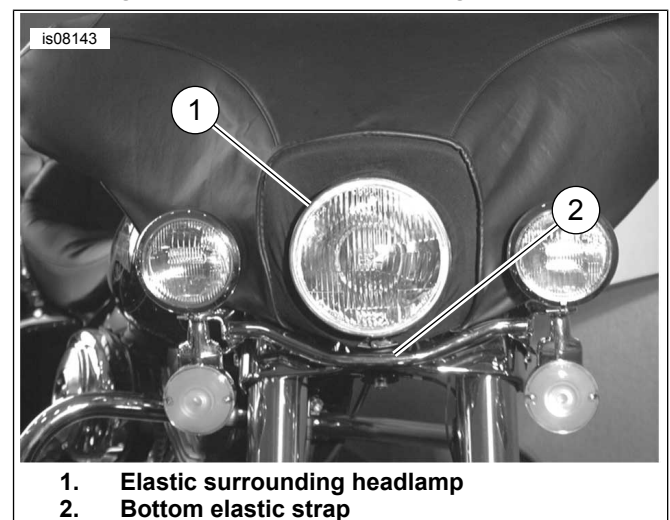
Figure 2. Proper Orientation of Fairing Bra (Headlamp Trim Ring Not Installed)

7. Install the bottom elastic strap below the fairing seal under the headlamp.
8. Install the headlamp trim ring using the Phillips screw removed in Step 5.
